Test Report

**INVESTIGATION OF WIND PROJECTILE
RESISTANCE OF
PRECAST CONCRETE PANELS**

Mr. Jason Hensley of FABCON contacted the Wind Science and Engineering (WISE) Research Center at Texas Tech University to determine debris impact resistance of their concrete panels for the tornado and DOE 1020-02 protocols. Tests were conducted on October 18, 19 & November 1, 2007. The specifics about each test, results, and conclusions follow.

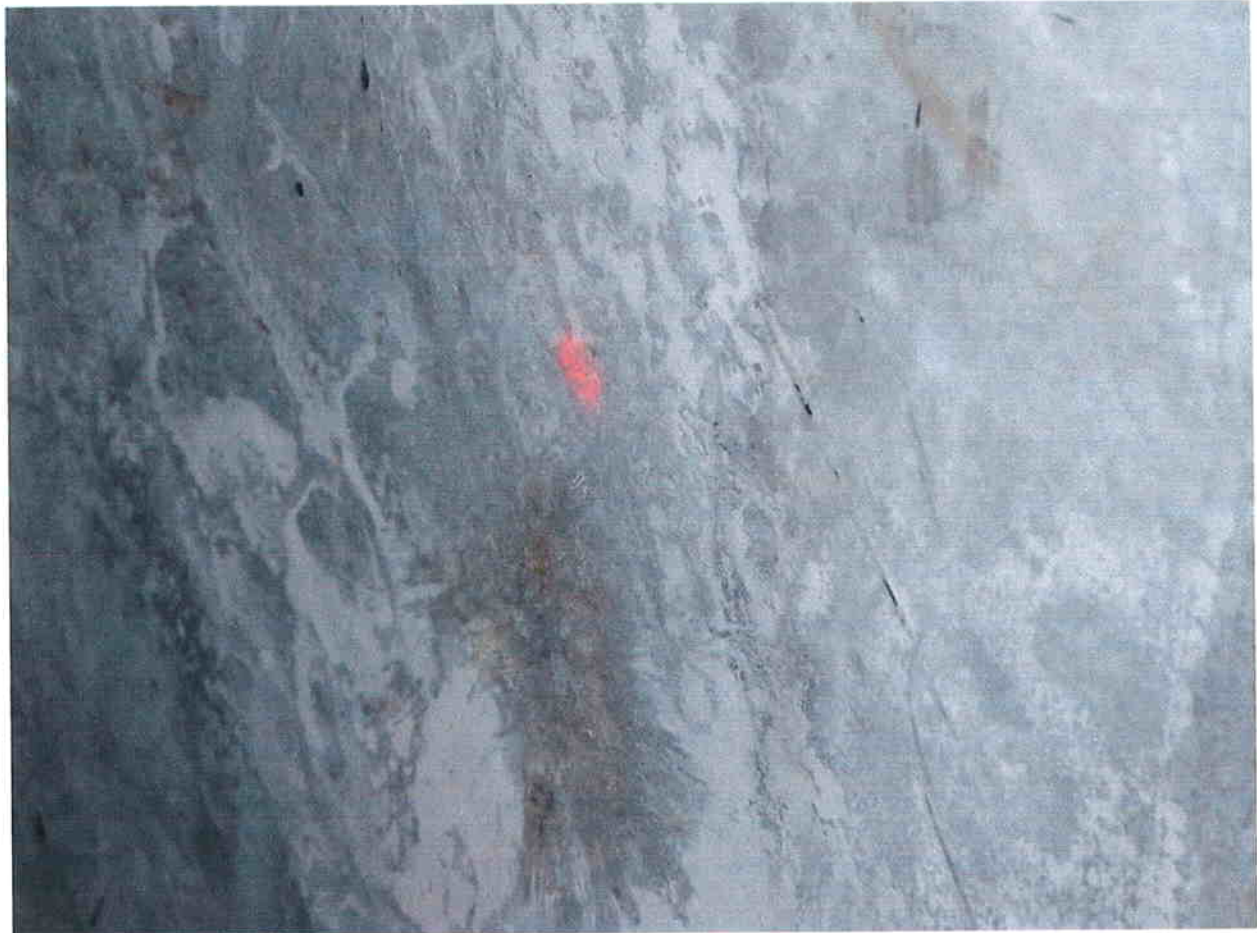
The wall sample was impact in the center by the higher speed wood DOE Missile II. There was no remarkable damage produced on either side of the sample.

DOE Wood Missile Impact II of Series 1, Specimen 1 Panel

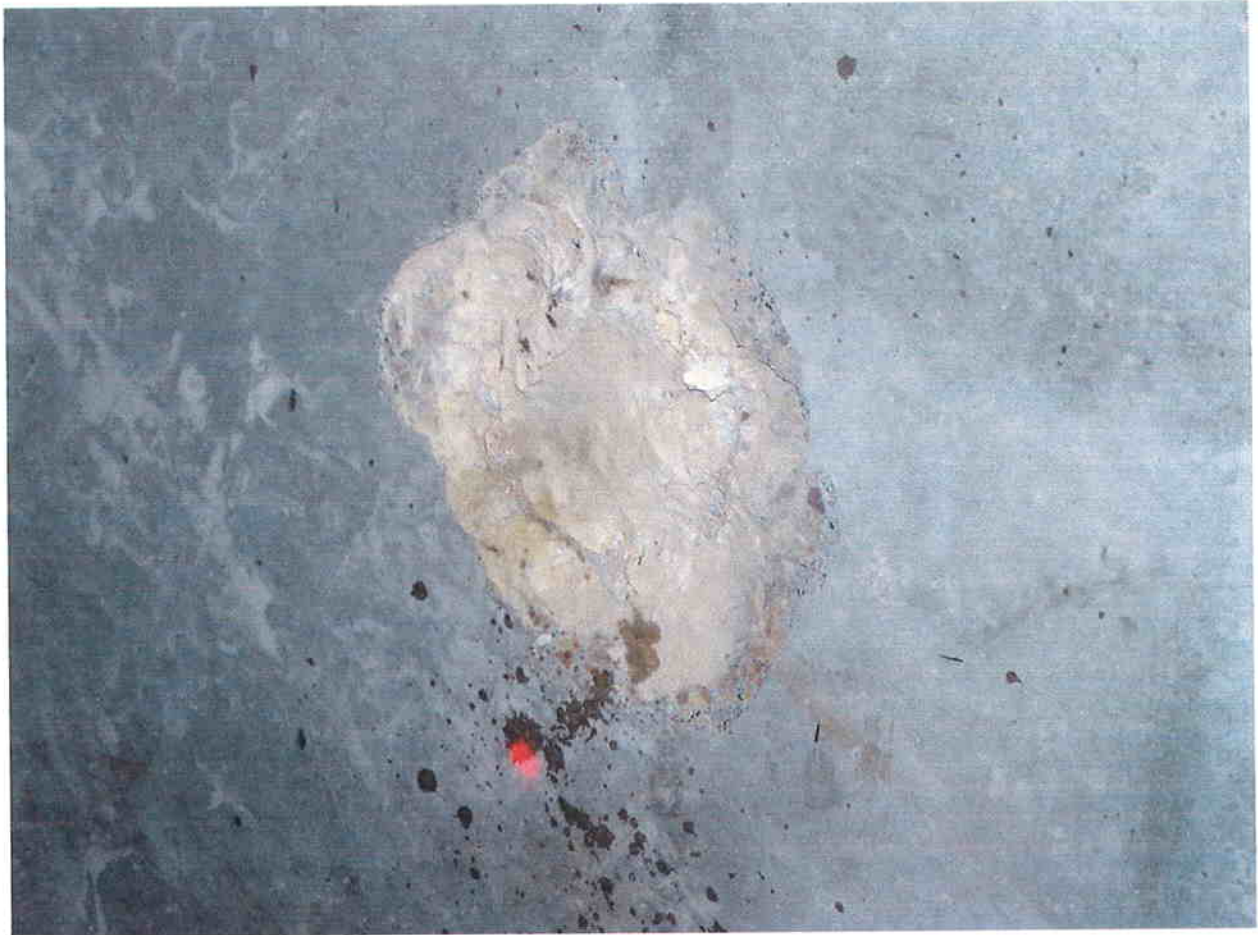
Missile IV imprint on Series 1, Specimen 1 Panel

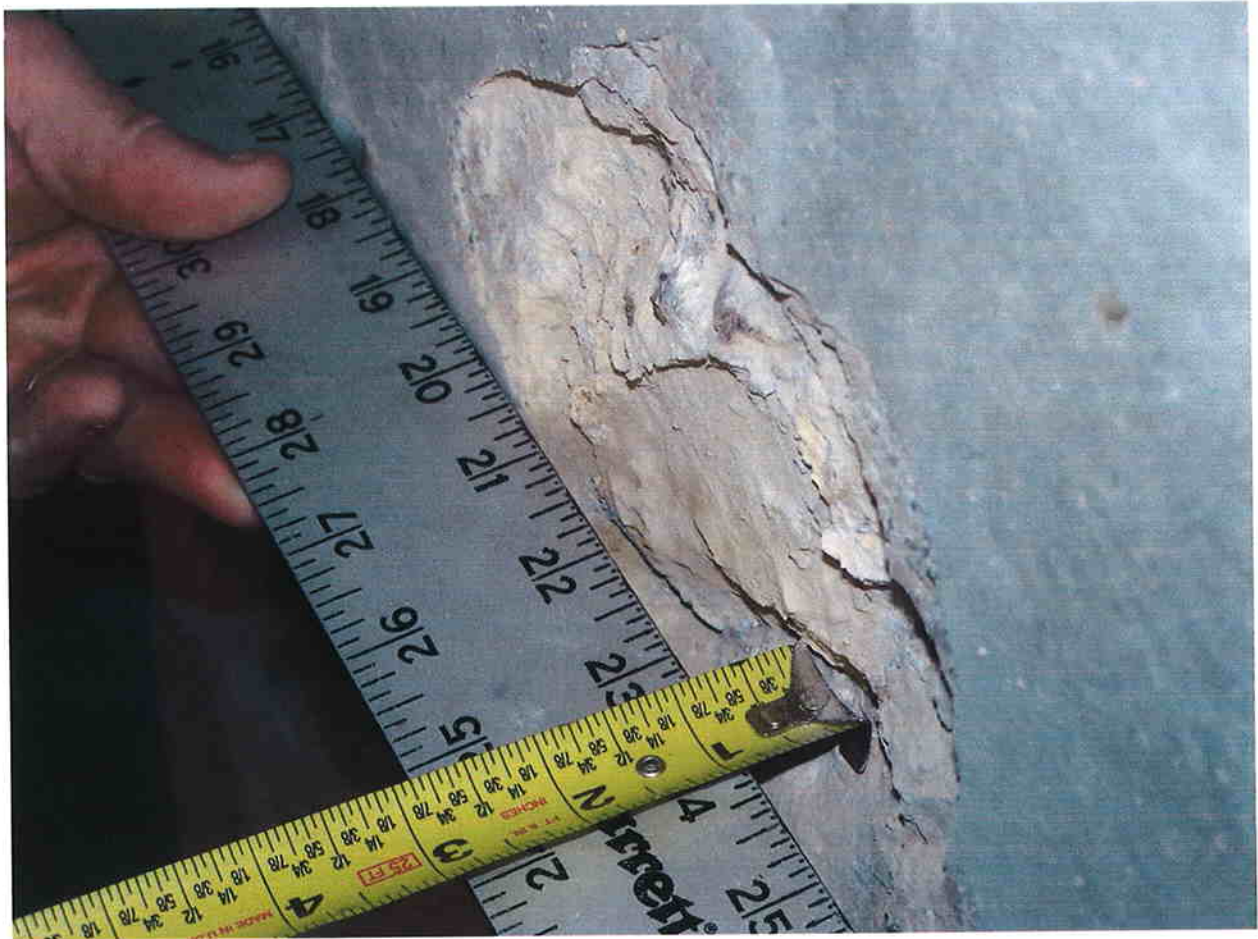
Missile Imprint Depth produced by DOE Pipe Missile IV

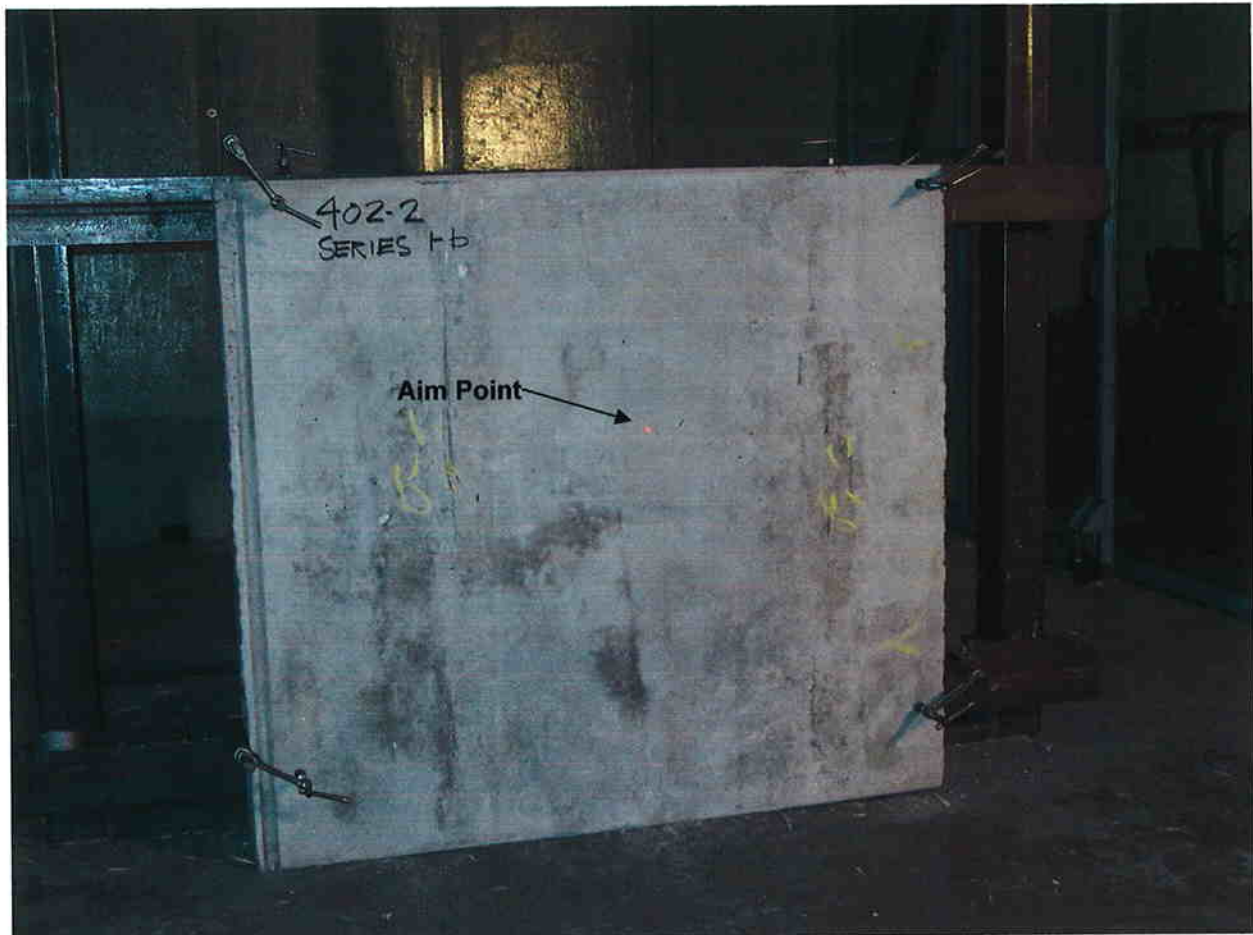
Series 1, Specimen 2 Panel erected for Doe Pipe Test

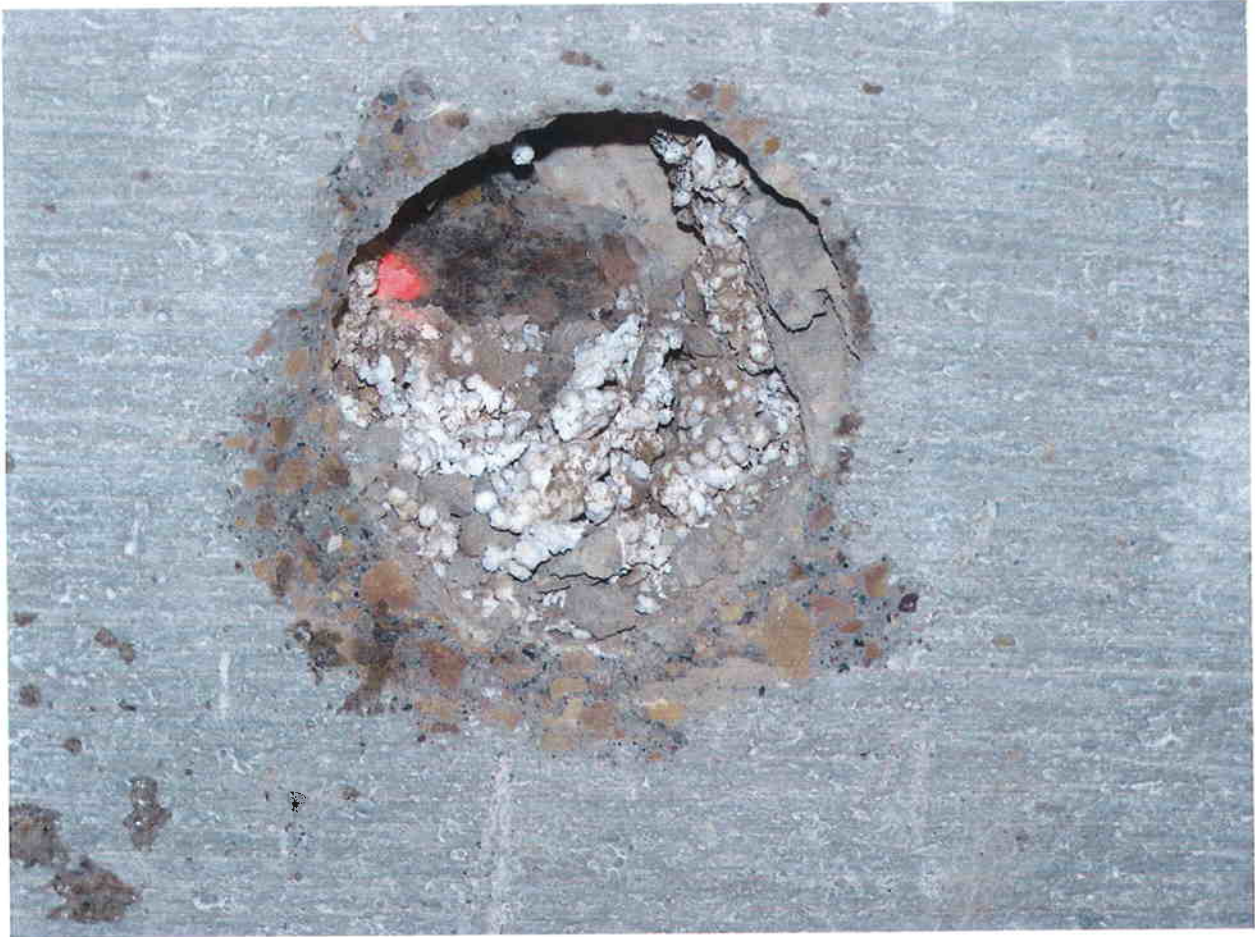
Pipe Missile Imprint

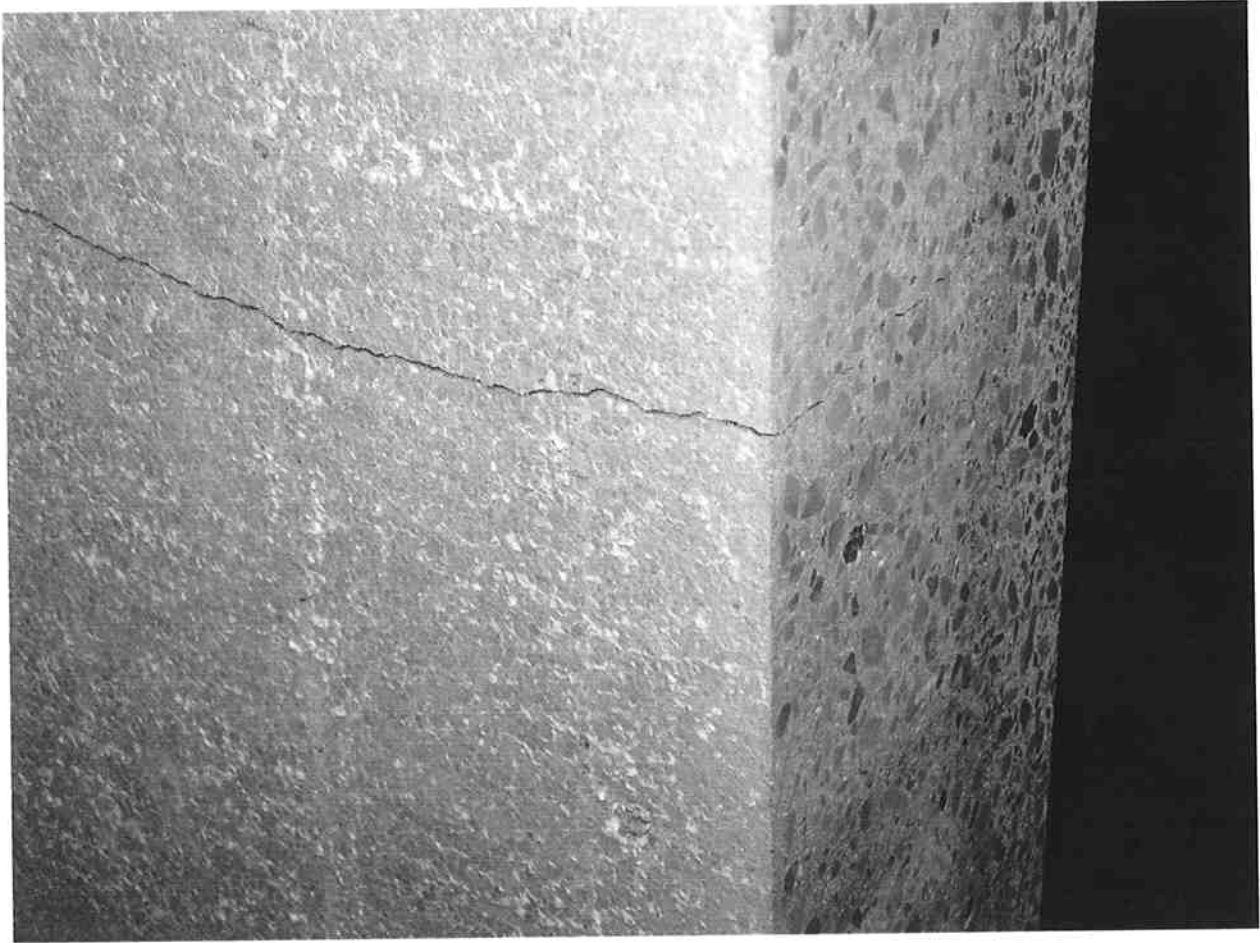
Horizontal Crack produced by DOE Pipe Missile

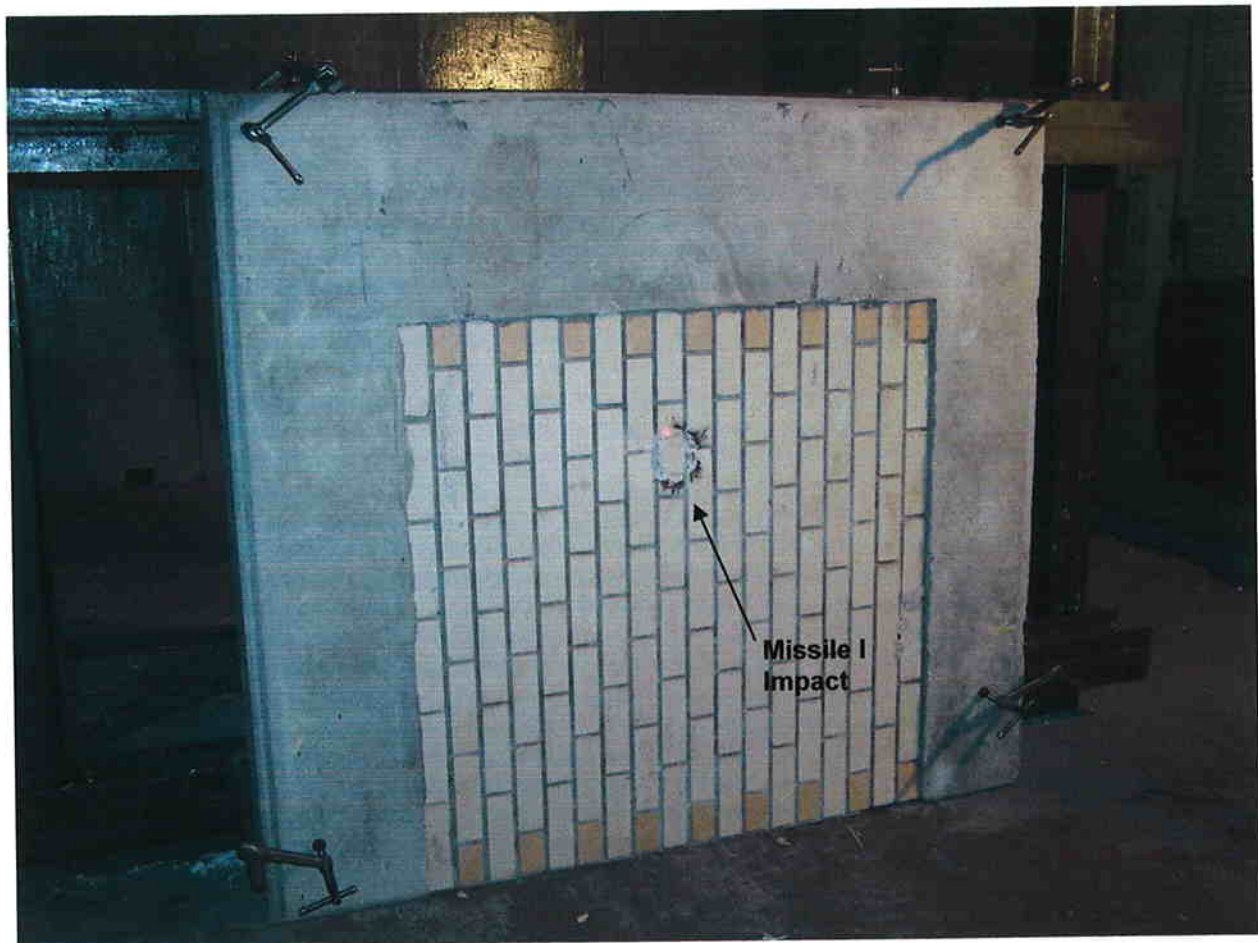
The Series 3, Specimen 2 panel was installed as a validation test of the previous test results observed on Specimen 1. Specimen 2 was impacted in the panel center. The impact produced a rough 5 ½-in. diameter impact crater on the exterior with penetration up to 1 1/8-in. A horizontal crack across the entire wall face was observed. The crack started at the impact point and continued diagonally to the upper left corner. The crack maximum width measured 1/16-in.

Missile Impact I of Series 3, Validation Specimen 2 Panel by DOE Pipe Projectile

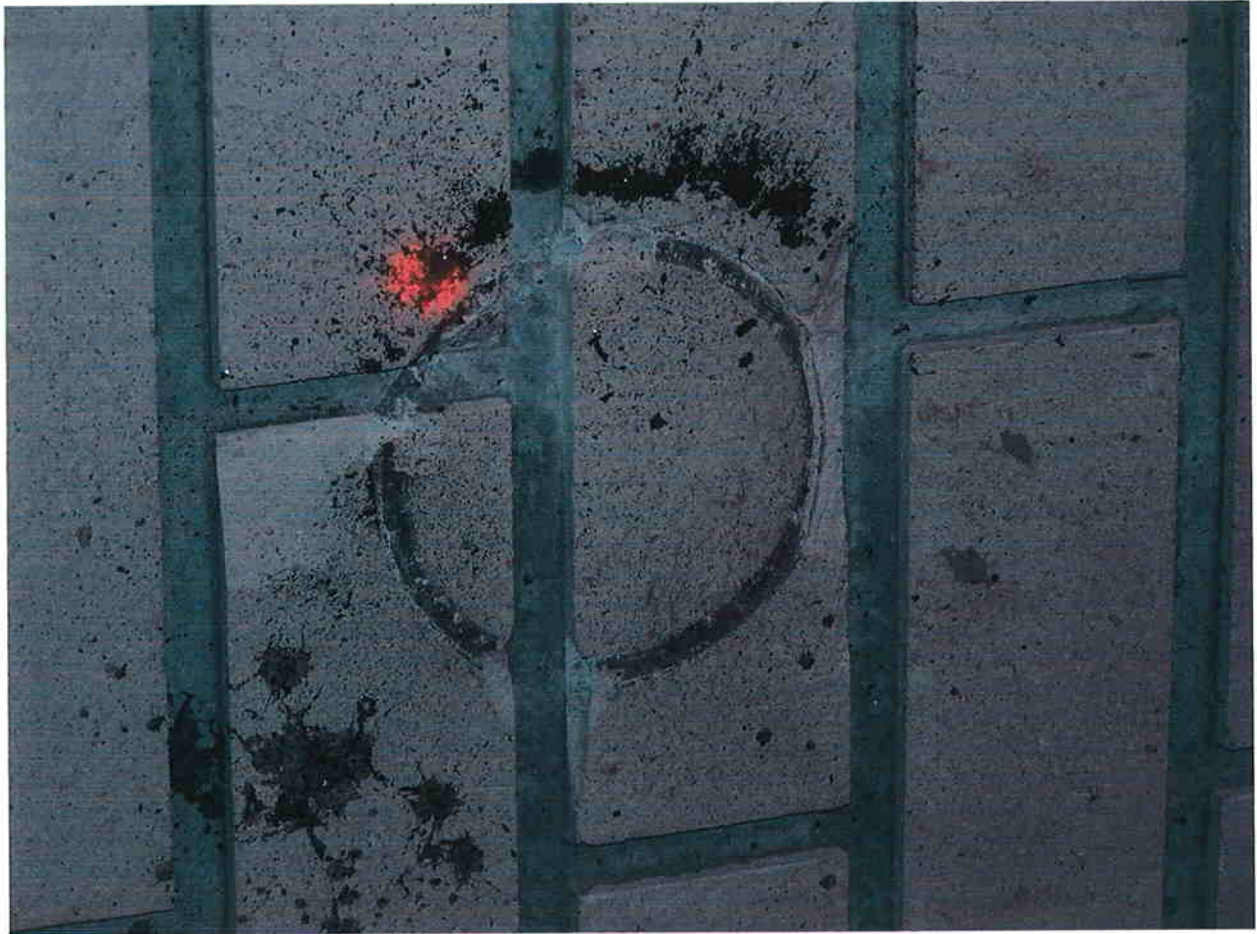
Missile Imprint from Missile I

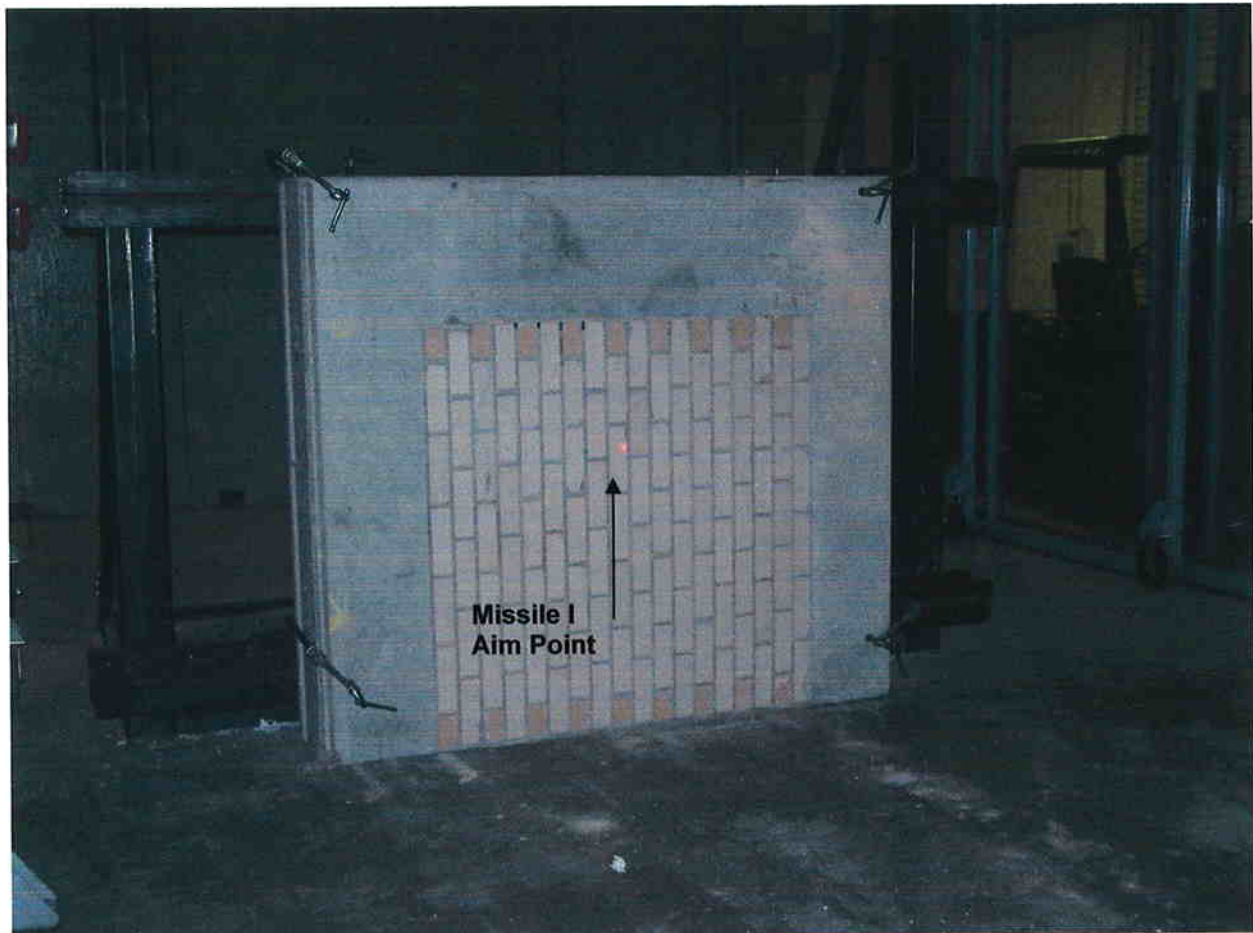
Series 4, Specimen 2 Panel readied for testing

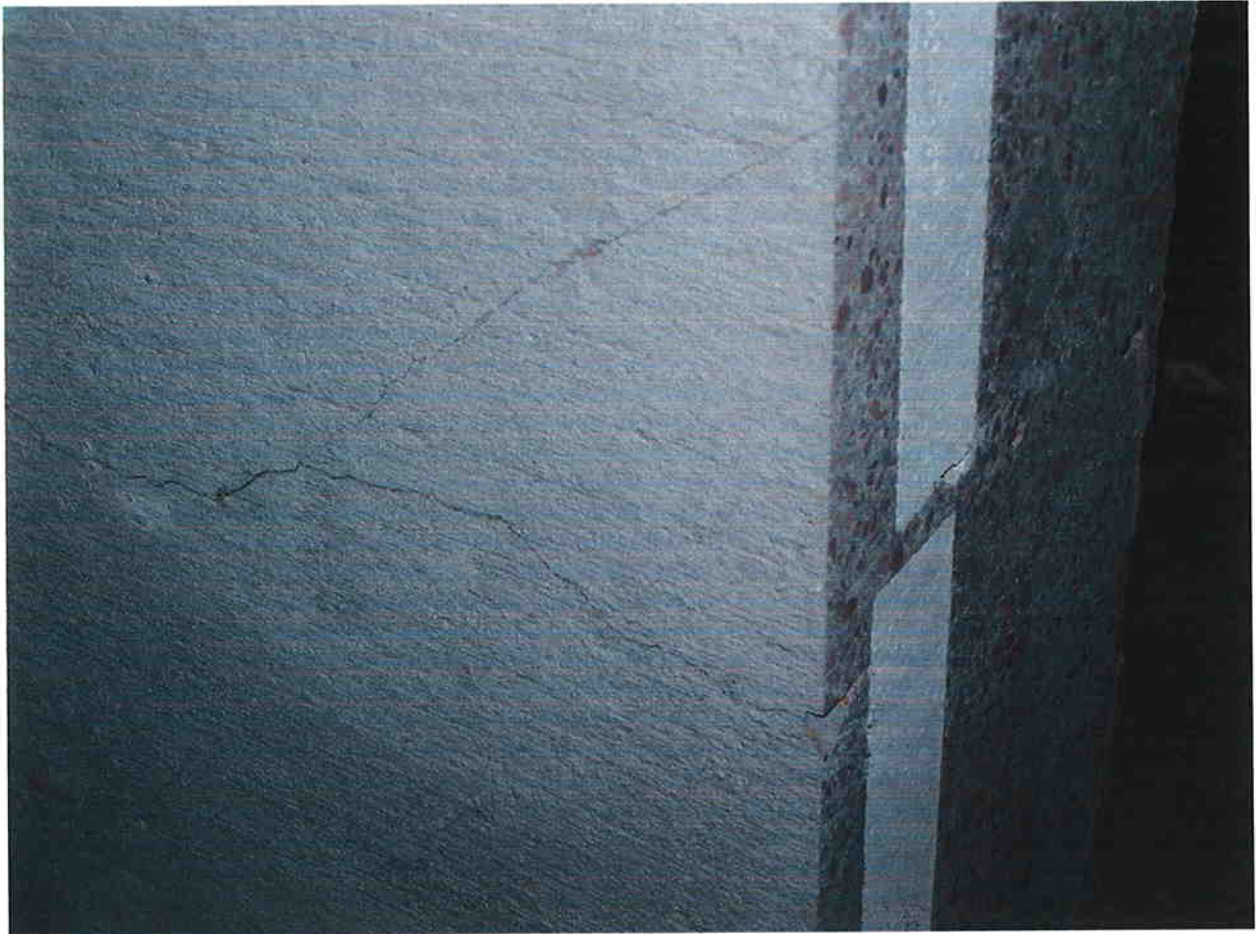
Cracking at right edge of panel backside

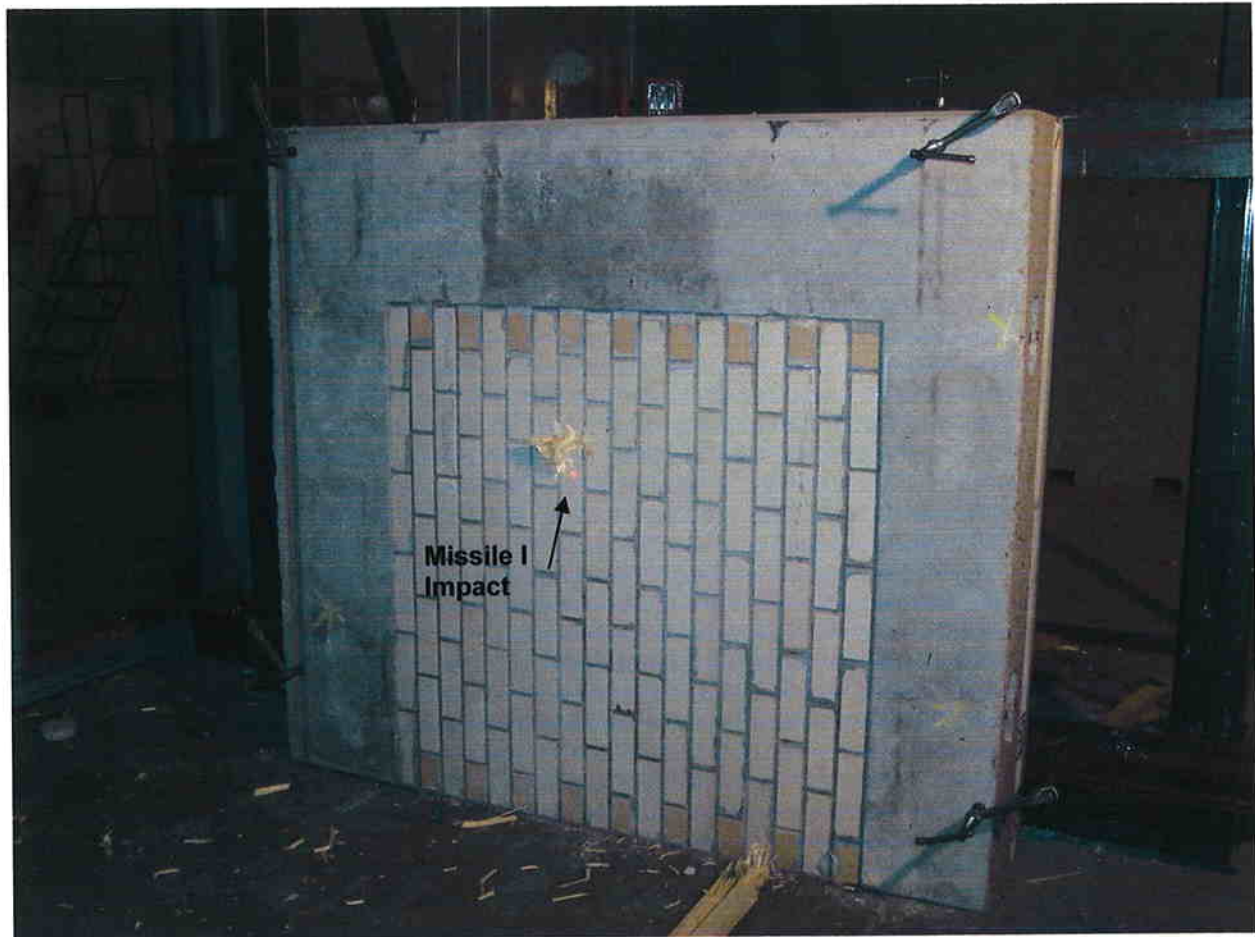
The Series 5 sandwich panel was erected with the 8-in. concrete face with the brick veneer facing the canon. The 2x4 wood missile impacted the center of the panel producing no remarkable damage.

Missile Impact I of Series 5, Specimen 8-in. concrete side

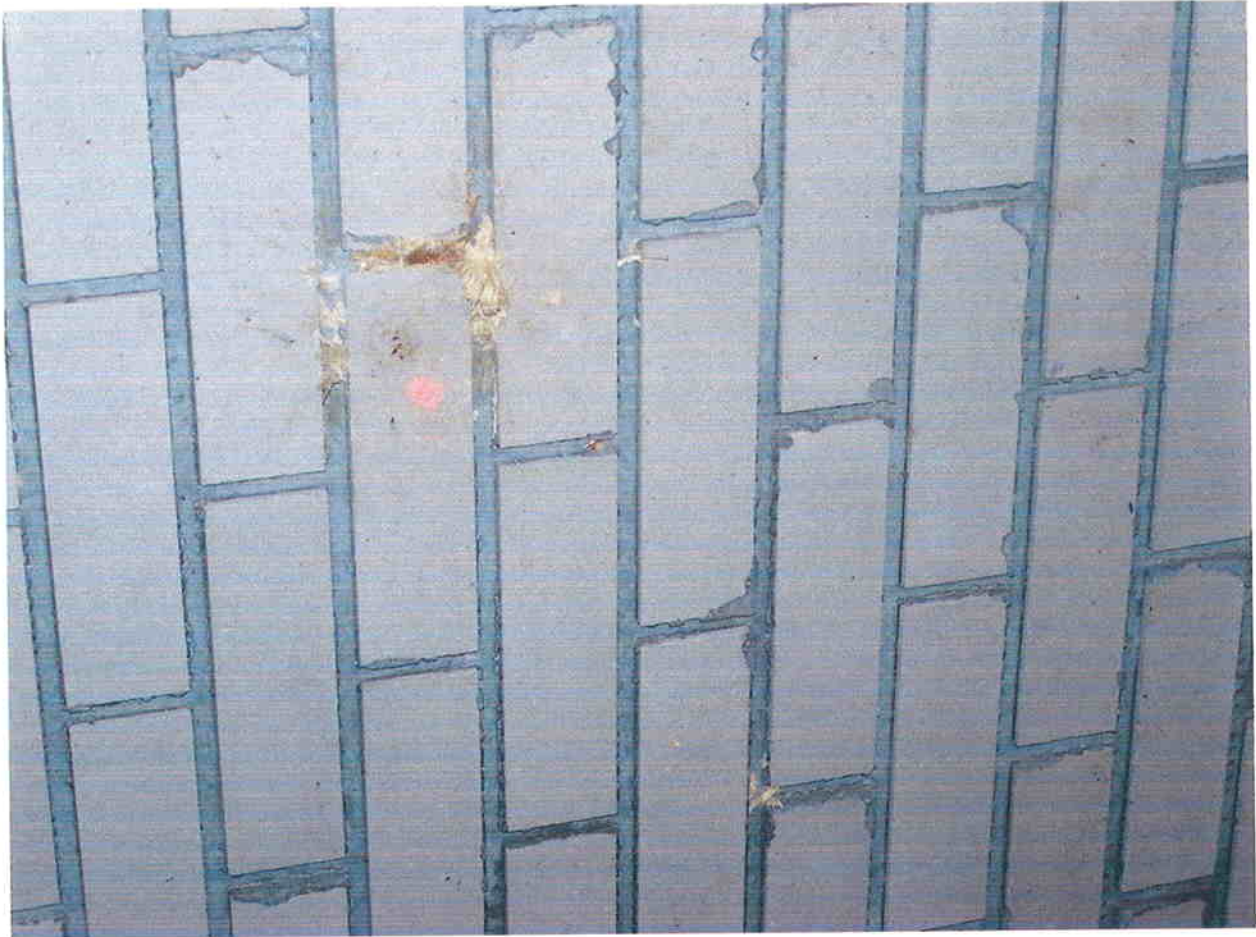
Missile III Imprint on Series 5, Specimen 1 8-in. panel face

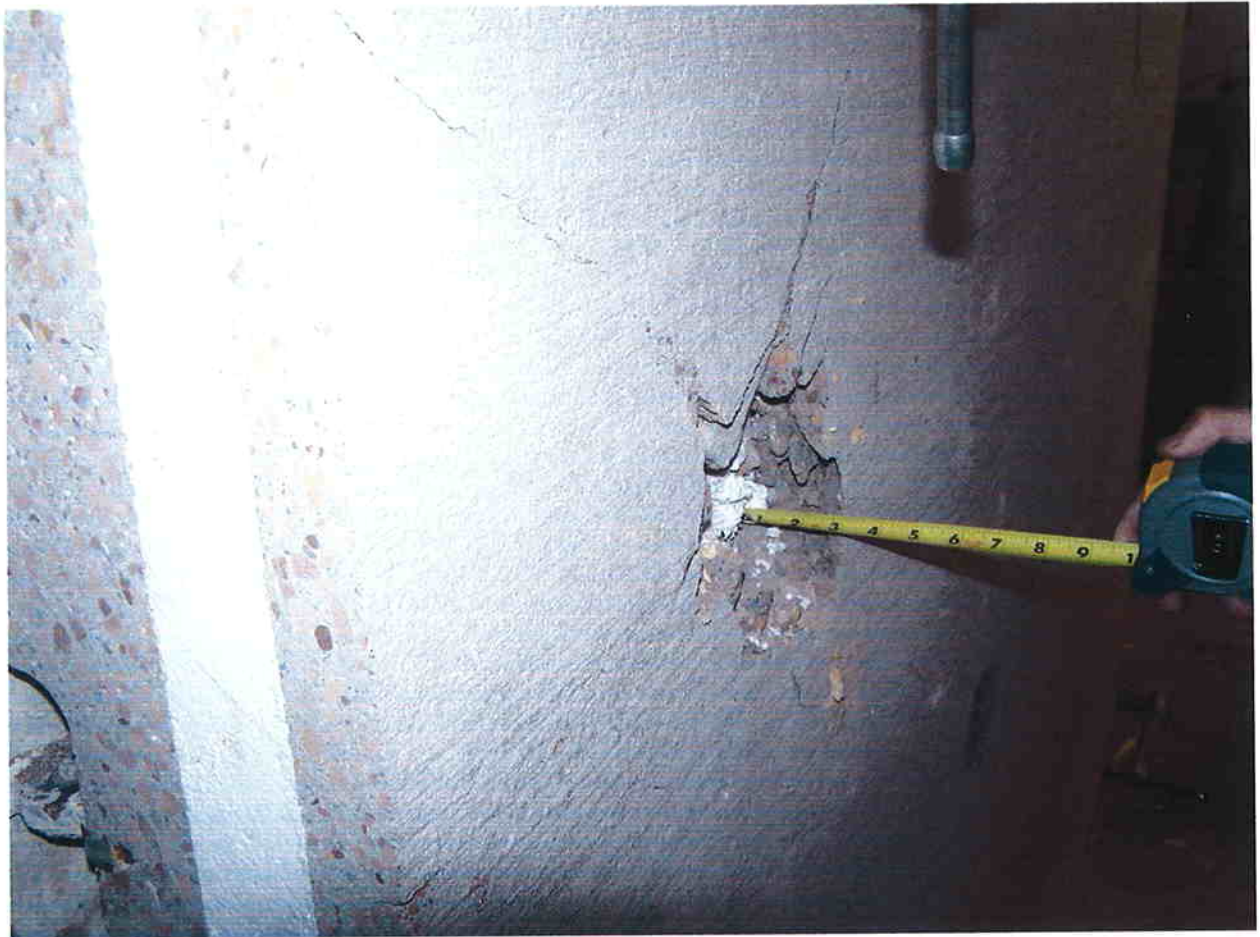
Series 5 Panel Penetrated 3-in. by Missile V
